JANUARY 1965

THE NAVAL AVIATION SAFETY REVIEW

## Single-Engine Versus Twin-Engine . . . What Can Happen With A 50 Percent Power Loss

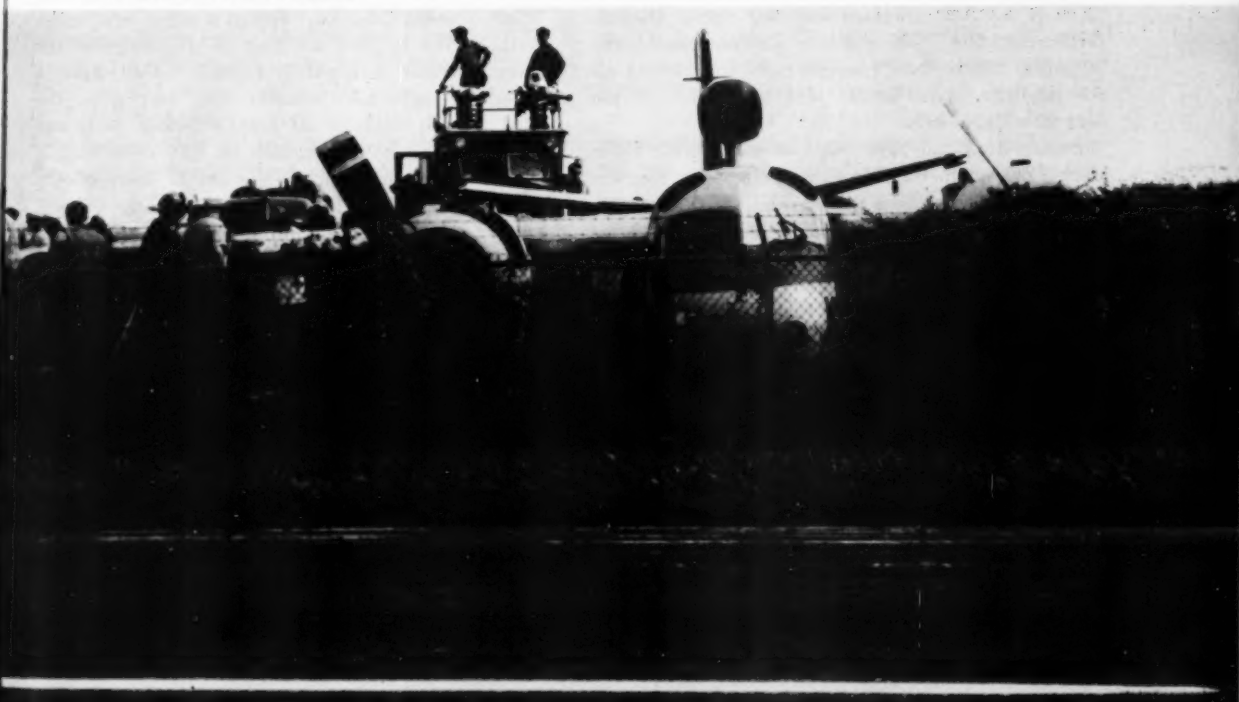
Accident board said pilots were in too much of a hurry to get down when port engine had to be feathered. Straight-in approach was requested and tower offered nearest straight-in runway due to urgency of request. Downwind landing ended in ditch off end of hard surface.

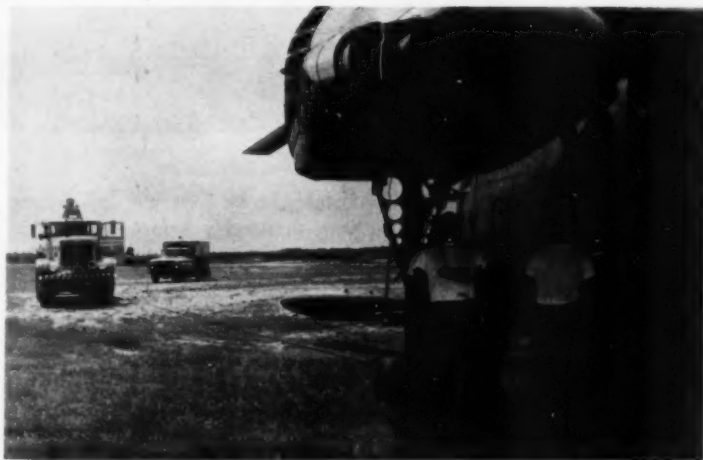
HMH-461 UNSAFE GEAR TECHNIQUE DURING HOVER

The port wheel of the CH-37C had been damaged and wouldn't lock down. The crash crew and maintenance personnel attached a chain around the gear and hooked the truck crane cable to it. Steady pressure was provided by the truck's winch until the aircraft could be safely landed and a jack installed.

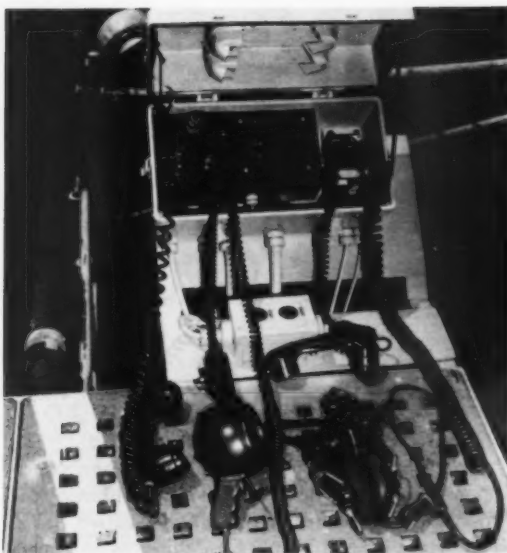
LSO commconsole on LSO platform on CVS-20, gear rigged.

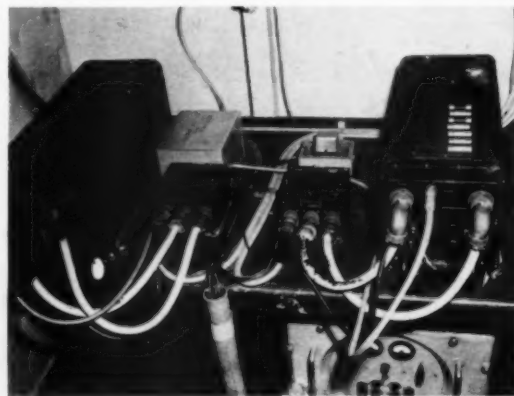
Photo shows an oblique view of the Dual ARC-27 installation.

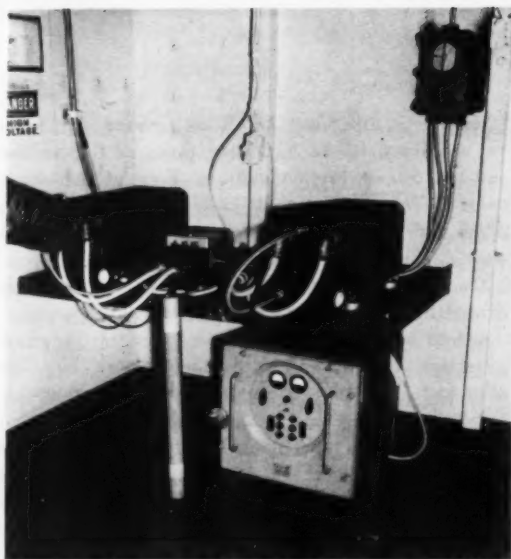
This photo shows the entire below deck installation of the Dual ARC-27.

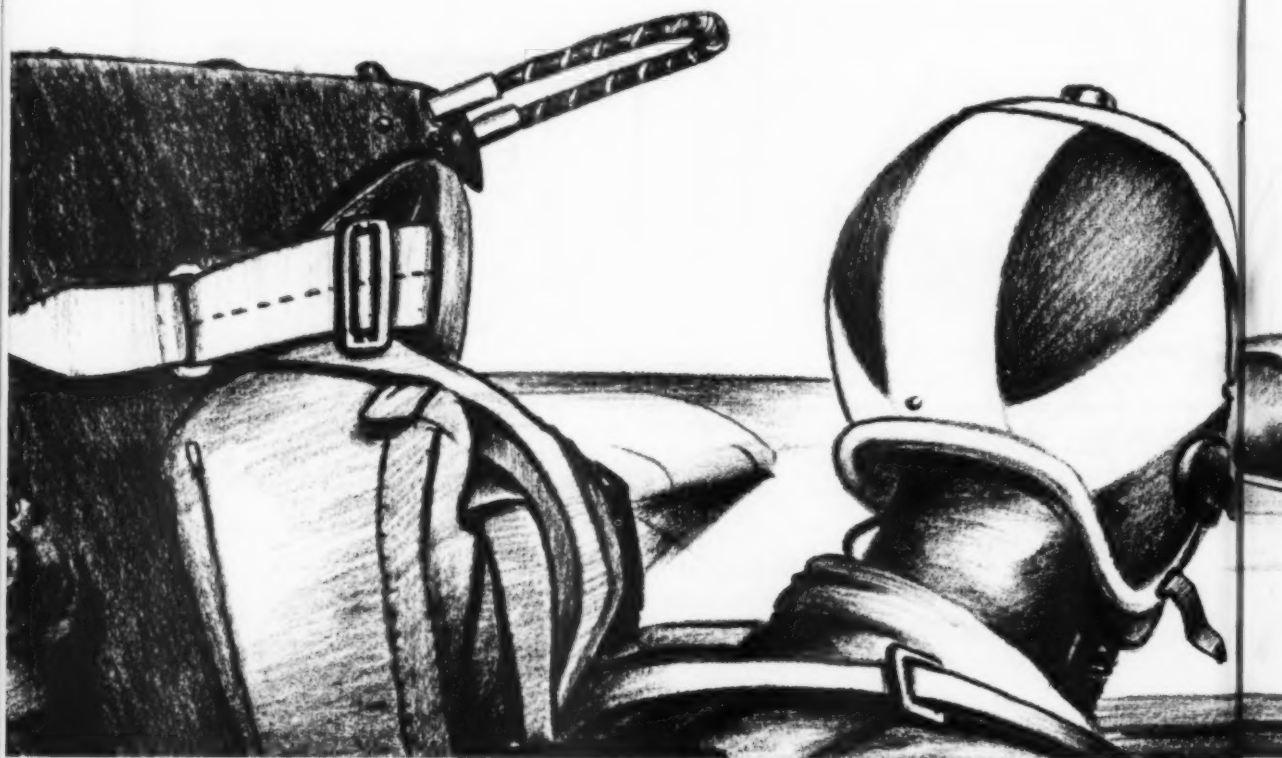
Pilot and photo technician were found in the wreckage of an RA-3B. Both men had died of hypoxia prior to the crash . . . ironically, investigators found the crew section of the cockpit area in "remarkably excellent condition." The victims' crash injuries were only small cuts and bruises. The accident which never should have happened in the first place was considered survivable but the airman's insidious enemy—hypoxia—had won this round in man's battle to survive at altitude.

The Cougar pilot observed that the person in the right seat was slumped and apparently unconscious.
